FINAL REPORT  
JANUARY 1998

REPORT NO. 96-03

BULLPUP  
CHEMICAL OVERPACK  
CONTAINER EVALUATION

Prepared for:  
U.S. Army Chemical and Biological  
Defense Command  
ATTN: AMSCB-CMO  
Aberdeen Proving Ground, MD 21010-5423

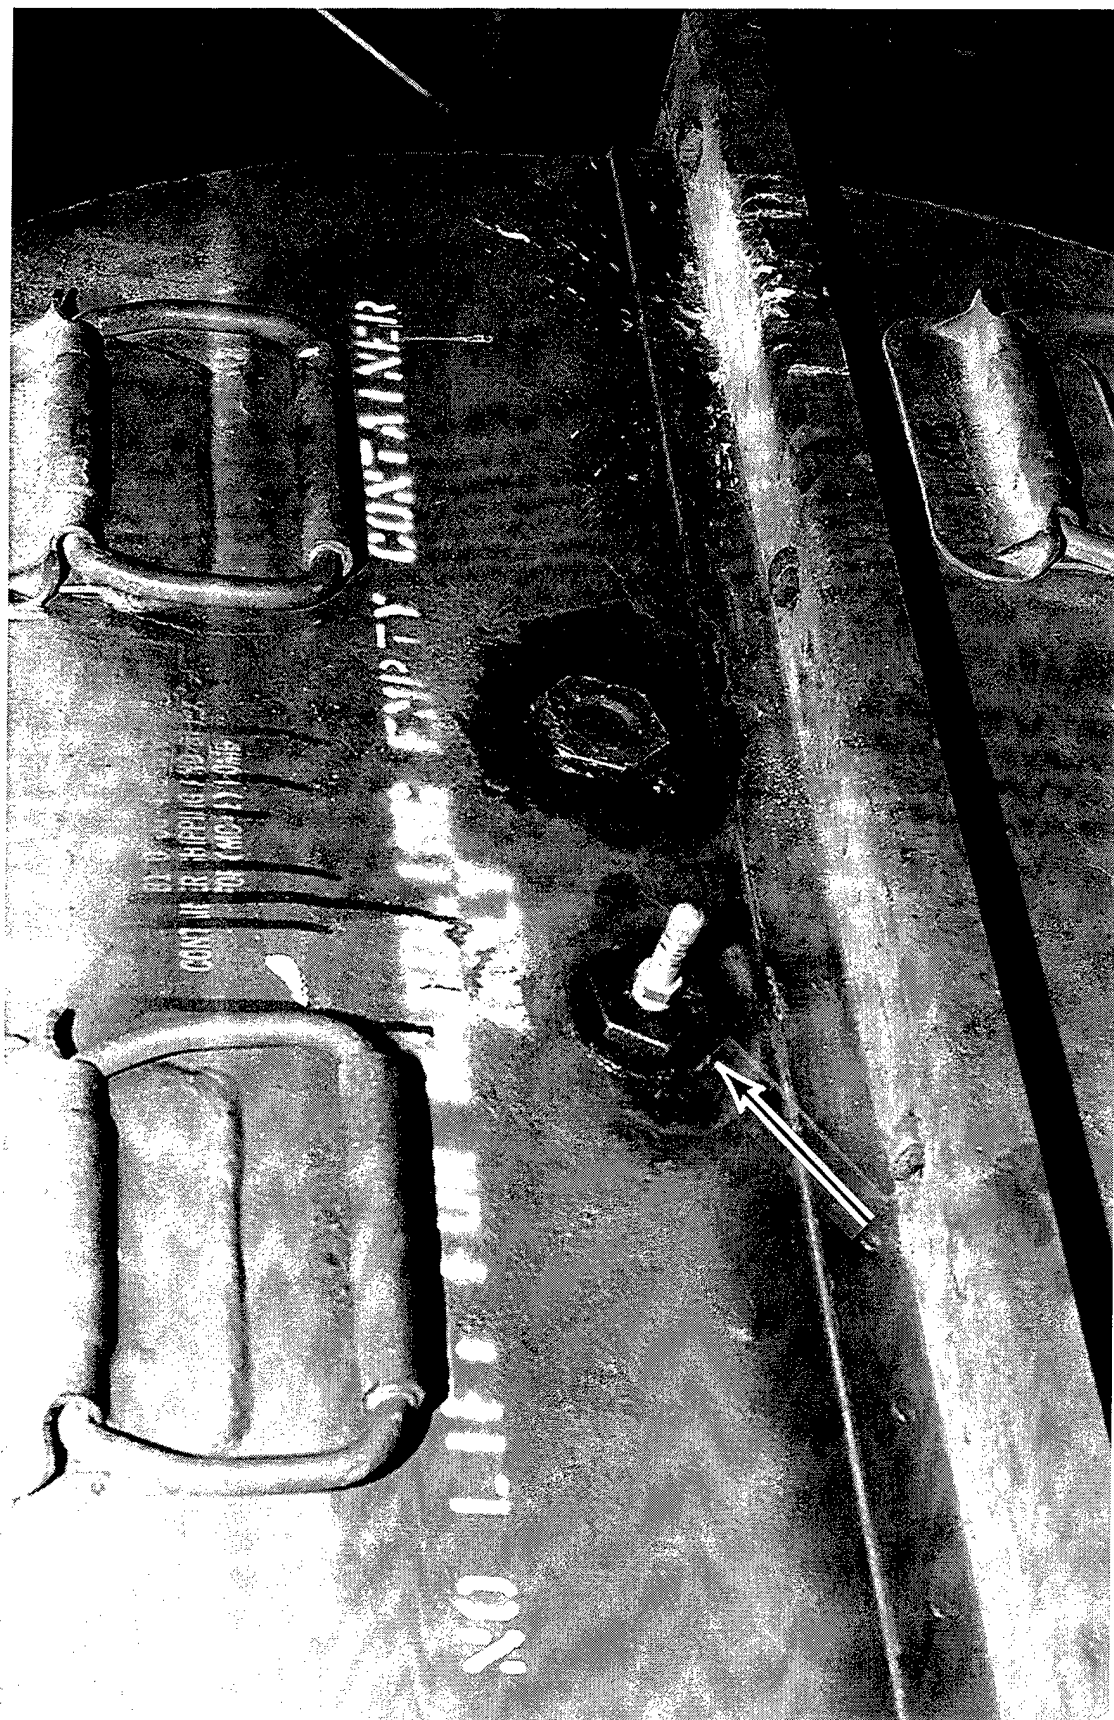
PHOTO NO. A0317-SCN98-DEVOVPK8.TIF. The arrow indicates a threaded plug with a shraeder valve installed. The plug had a butyl rubber washer and butyl rubber sealant placed on it prior to installation. The shraeder valve threads were covered with Teflon prior to installation.

combination with a butyl rubber gasket and butyl rubber sealant torqued to 350 in-lbs. Upon assembly of the container, a pressure decay test should be performed to verify its leak integrity.
